PROPERTY INSPECTION REPORT

James DAngelo
Certification#NACHI10032611
HomeTech Property Inspections

1234 Happy Street
Inspection Prepared For: Best Client Ever

Date of Inspection: 7/4/2019

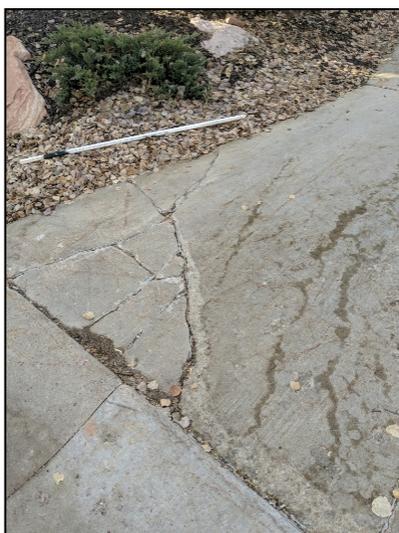
- Cracks noted. Sealing of cracks will help to reduce further damages.
- Surface raised/settled
- Spalling noted, this is a surface condition, it does not appear to effect function at this time but may continue to degrade over time.

Cracked and damaged areas

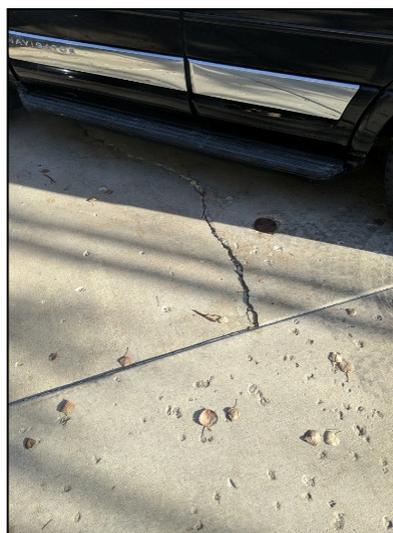
cracks

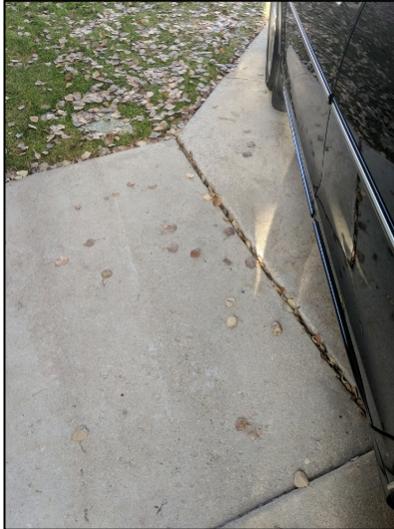
settlement

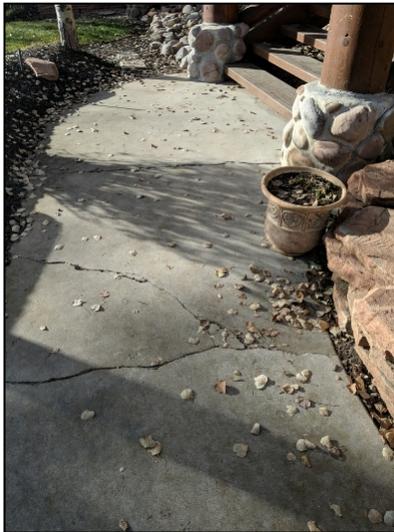
- Cracks noted. Sealing cracks will help to reduce further damages.

cracks

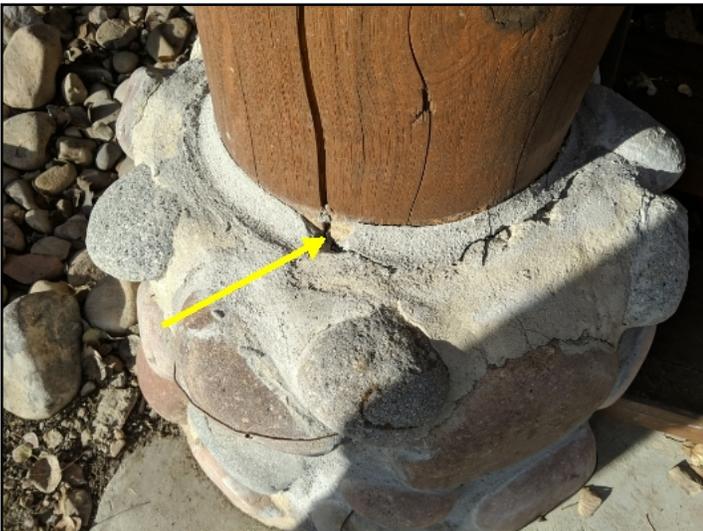
- Overall condition of the deck and rails appears to be in satisfactory condition overall.
- **The main posts have some wood rot and damage where the post meets the stonework. Recommend further assessment and repairs as needed. Mortar maintenance is advised on the stone columns as needed.**
- **There is some exposed OSB sheathing and a lack of proper flashing under the entry area deck. Recommend further assessment and improvement.**

Posts have water damaged wood where they meet the stonework

Grounds		
Page 7 Item: 4	Deck Areas	<ul style="list-style-type: none"> • The main posts have some wood rot and damage where the post meets the stonework. Recommend further assessment and repairs as needed. Mortar maintenance is advised on the stone columns as needed. • There is some exposed OSB sheathing and a lack of proper flashing under the entry area deck. Recommend further assessment and improvement.
Page 8 Item: 7	Vegetation Observations	<ul style="list-style-type: none"> • Trim trees away from the structure anywhere that they touch it, pictured is an example, check all areas and make improvements as needed.
Page 9 Item: 9	Exterior Electrical	<ul style="list-style-type: none"> • One outlet did not function, repair or replacement advised. Under front deck GFCI would not reset.
Siding/Trim		
Page 11 Item: 2	Trim Condition	<ul style="list-style-type: none"> • Windows on the lower level are not sealed properly around the edges, further assessment and sealing advised. This is an important improvement to make, it will better seal the home.

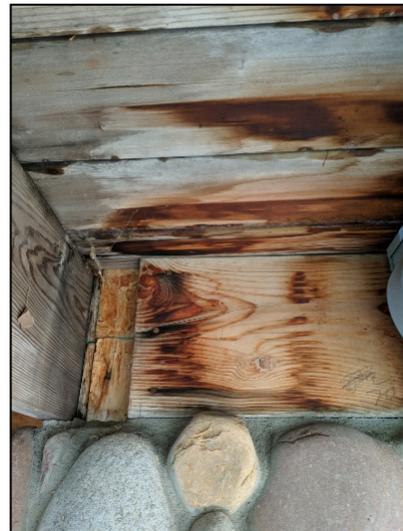
Exposed OSB and lack of flashing under front deck

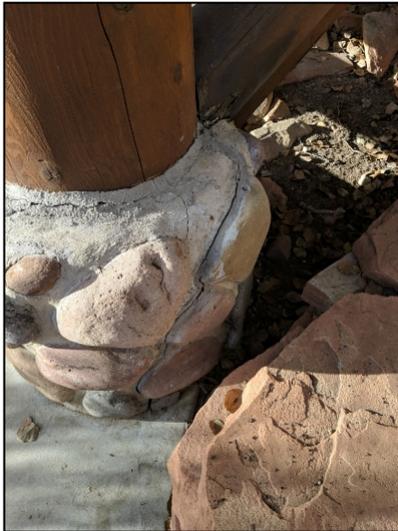
Mortar maintenance advised on stonework

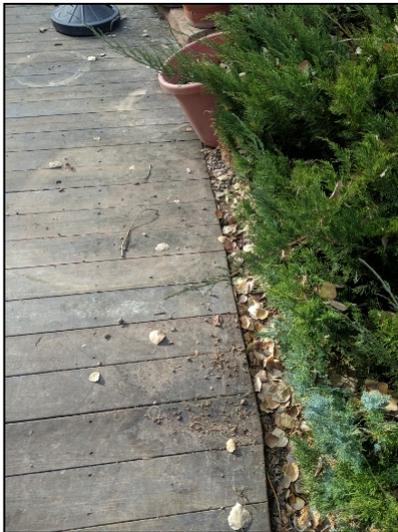
Earth to wood contact but no major issues

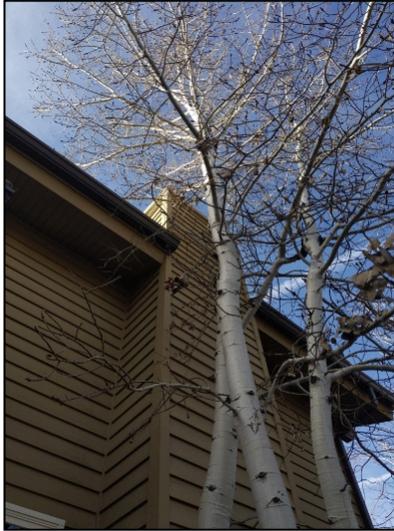
- Trim trees away from the structure anywhere that they touch it, pictured is an example, check all areas and make improvements as needed.

Trim trees

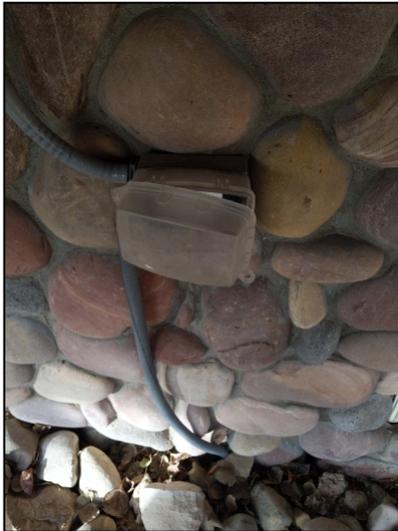
- Visible and accessible exterior outlets were tested and were generally functional at the time of inspection
- Loose exterior light trims. Adjustments advised as needed.
- One outlet did not function, repair or replacement advised. Under front deck **GFCI** would not reset.

Outlet under the front deck had no power

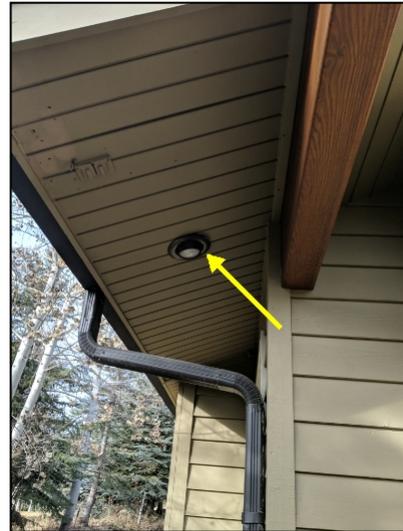
A few can lights are loose

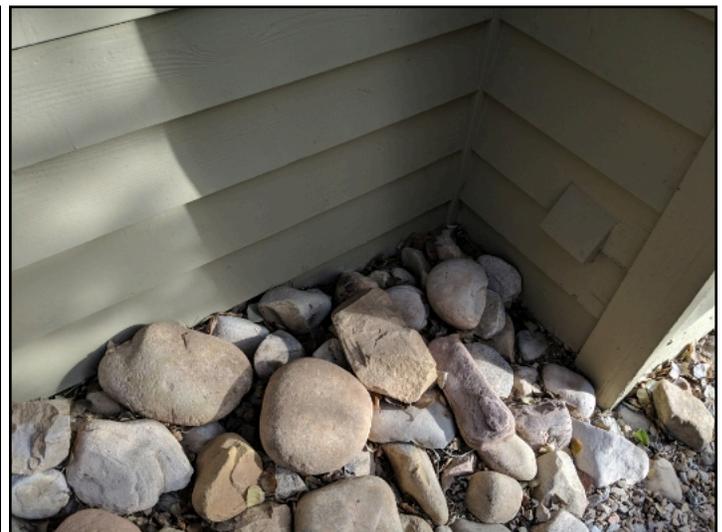
- Overall condition appears serviceable, no major issues noted
- Lower soils below siding. Grade should be below any wood materials.
- Storage door could not be opened due to gravel installation.

Wood in contact with Earth in a few areas

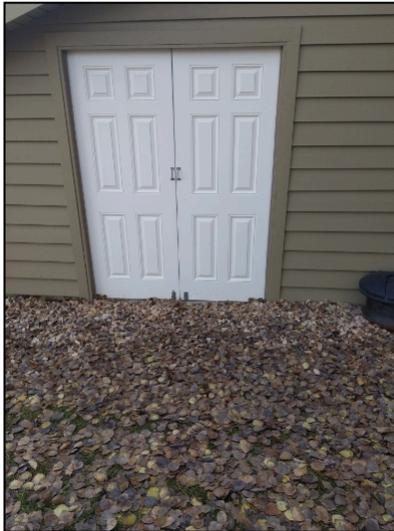
Storage area doors could not be opened

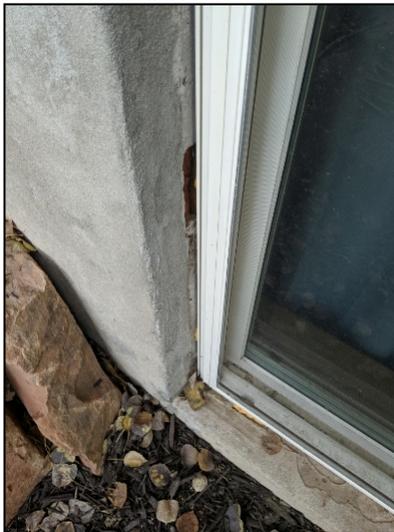
- Overall the visible trim areas appear to be in satisfactory condition, some areas are not accessible.
- Windows on the lower level are not sealed properly around the edges, further assessment and sealing advised. This is an important improvement to make, it will better seal the home.

Lower level windows are not sealed well around the edges

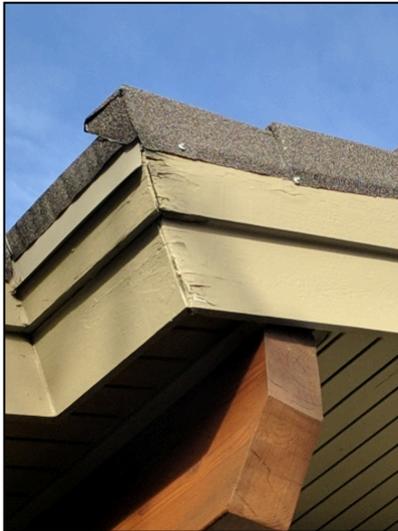
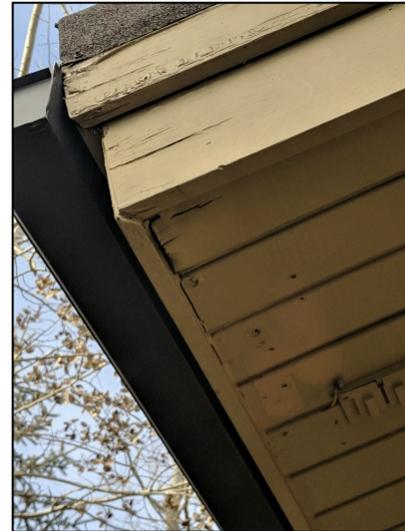
- Paint or stain is needed as part of regular maintenance. Pictured is an example, all areas should be assessed and maintained as needed.

Maintenance advised in some areas

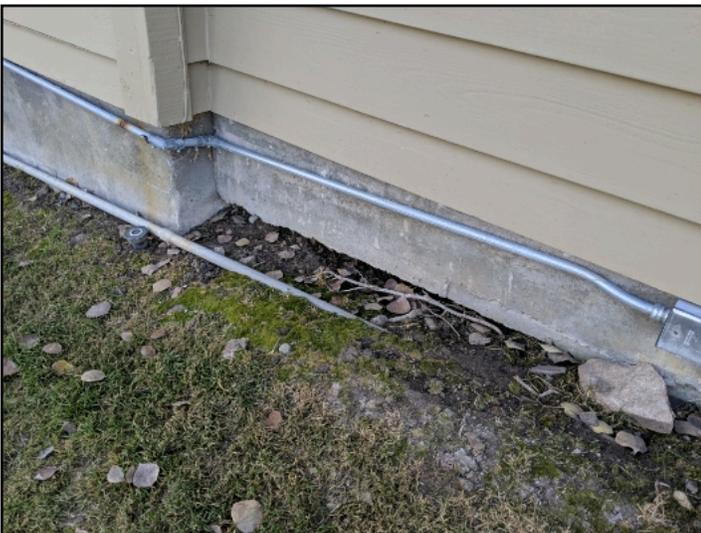
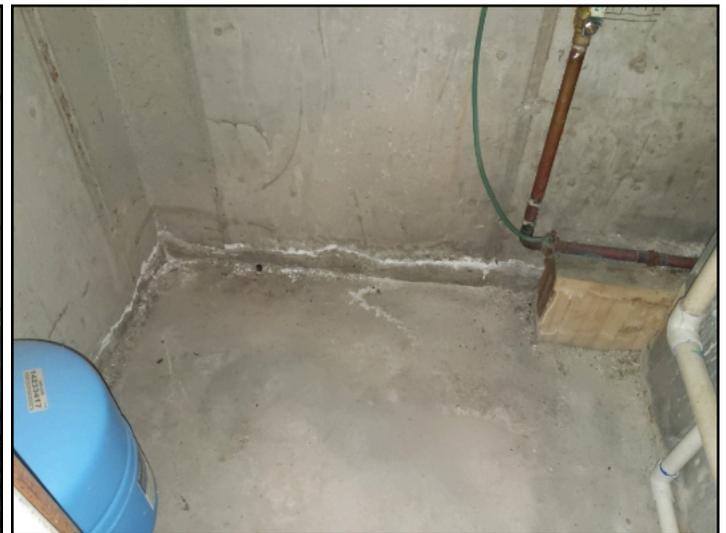
- Visible areas of the exterior foundation appear to be in serviceable condition overall, no major concerns were visible at the time of inspection. View was limited to visible areas above ground. We cannot comment on unseen or underground areas. Small or typical cracking may not be noted.
- **Hollow area noted under the storage room slab. Further assessment and improvement advised to avoid damages or settlement. This appears to have been an add on and not part of the main house foundation.**

Hollow under storage area slab

Foundation		
Page 12 Item: 1	Observations	<ul style="list-style-type: none"> • Hollow area noted under the storage room slab. Further assessment and improvement advised to avoid damages or settlement. This appears to have been an add on and not part of the main house foundation.
Electrical		
Page 16 Item: 2	Main Panel Condition	<ul style="list-style-type: none"> • Multiple wires are connected to a single lug on a circuit breaker where only one wire should be connected. This may be relatively common to see, however it is not correct and improvement is recommended.
Bathrooms		
Page 34 Item: 3	Toilets	<ul style="list-style-type: none"> • Water supply valve is leaking, repairs advised. Master bath.
Page 34 Item: 4	Tub/Shower Fixtures	<ul style="list-style-type: none"> • The jet tub motor did not come on when the control switch was operated. Further investigation is advised. We do not fill tubs or inspect the performance of the jets as part of this inspection. Master Bath

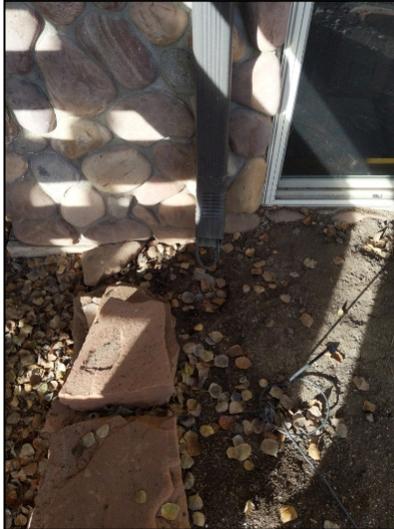
- Overall condition appears serviceable in the visible areas. Function or water carrying capabilities could not be tested.
- Route downspouts away from the building if possible, in any areas where water is being deposited by the foundation. This will help to keep water away from the home and it's foundation

Extend downspouts

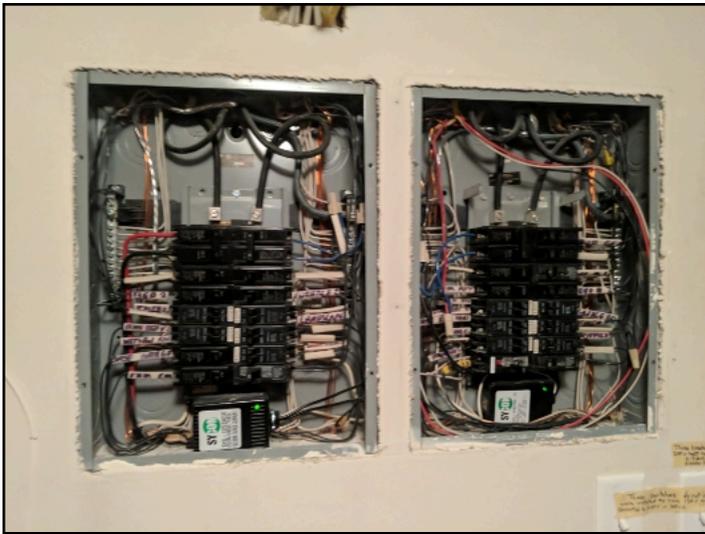
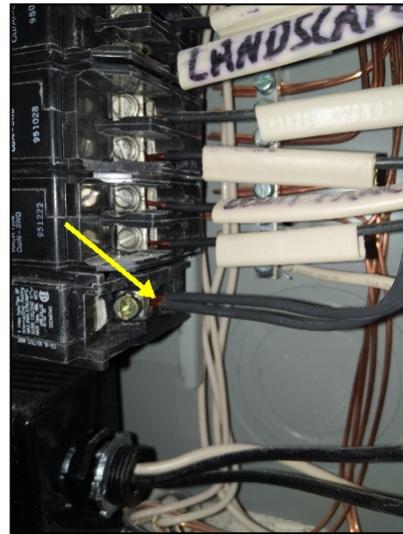
- Breakers and wiring appear to be in serviceable condition. The installation appears to be consistent with the standards at the time of installation.
- Grounding system is present
- Labeling present
- Multiple wires are connected to a single lug on a circuit breaker where only one wire should be connected. This may be relatively common to see, however it is not correct and improvement is recommended.

Double tap noted on one breaker

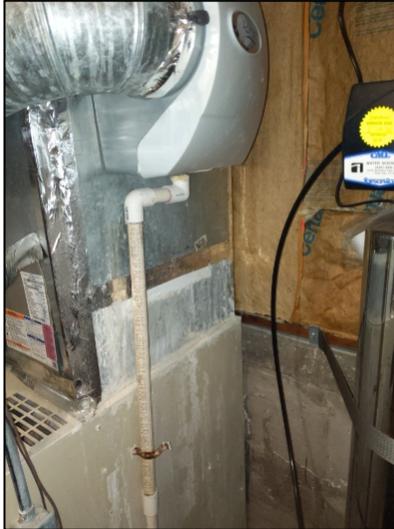
- A humidifier is installed. No major issues seen, humidifying capabilities or function not tested as part of this inspection
- Corrosion noted but no leaks, monitor. This may have been from an older unit

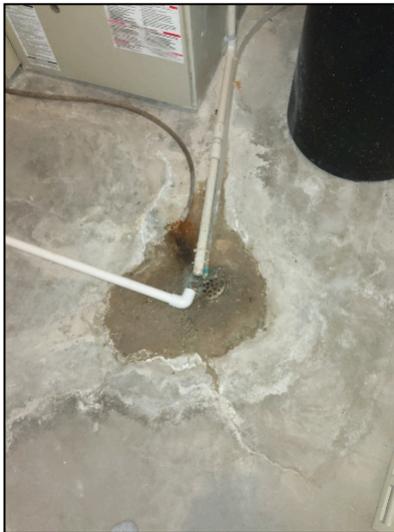
- Water is on the floor around the drain. Recommend cleaning drain and reassessing
- There is a small diameter soft line used for condensation. This is not ideal. We recommend having a proper diameter rigid line installed.

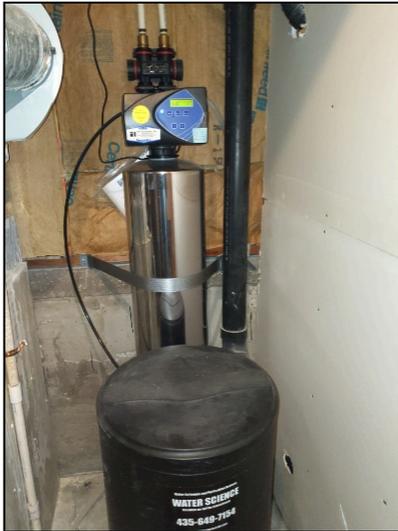
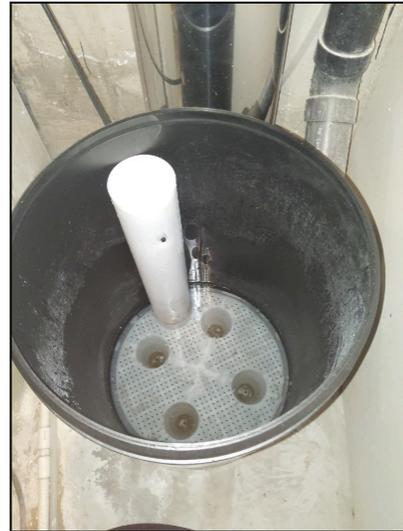
- Water softener installed. The function of these is not included in this inspection, we do not test water for hardness. Inquire with the manufacturer or contact the company on the tag in regard to service and maintenance needs. We will note any leaks or major defects.
- Salt tank is empty, filling advised.

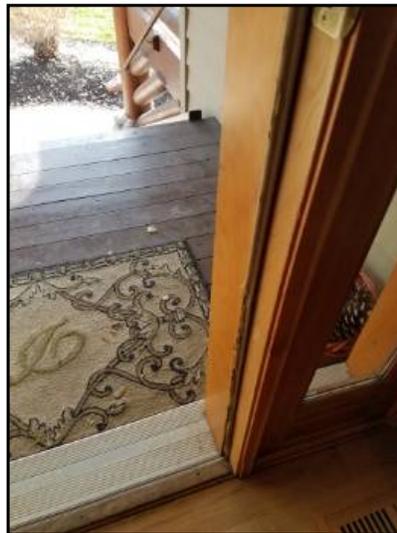
- Visible and accessible doors were assessed, overall condition of the door system appears satisfactory. Isolated issues may be listed below.
- Exterior door weather stripping is damaged or missing. [Entry Area](#)

Entry, weather stripping

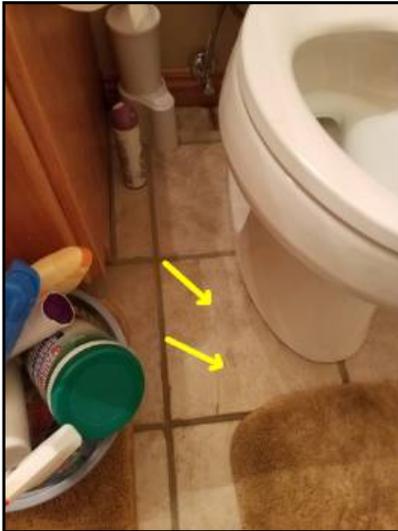
Hall bath, cracked tile

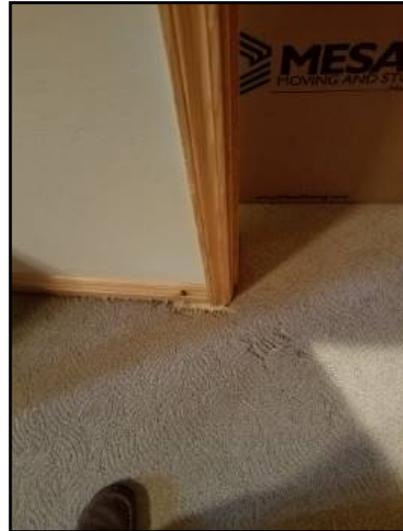
Carpet damage, basement bedroom

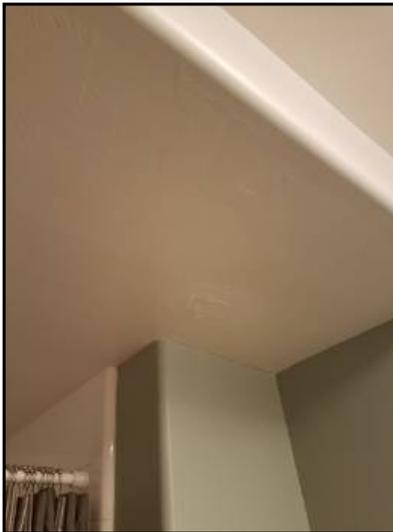
- Visible and accessible ceiling areas were assessed, overall condition of the ceiling system appears satisfactory. Isolated issues may be listed below.
- Signs of past repair noted, reason unknown, inquire with seller. Lower Level Hall Bath

Lower-level hall bath, repair

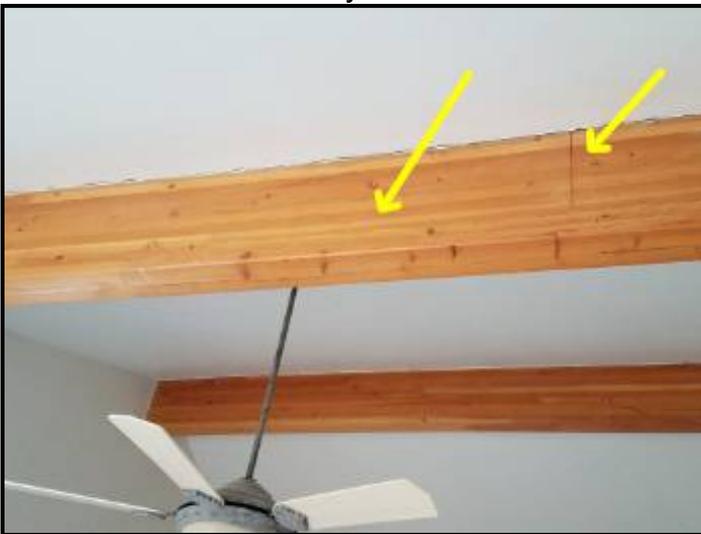
- Visible and accessible ceiling areas were assessed, overall condition of the ceiling system appears satisfactory. Isolated issues may be listed below.
- There is some drywall cracking noted. Be sure to take note of any future movement. Most common cracking is due to slight settlement or shrinkage of the construction materials. Surface repairs are advised to improve appearance. Family Room Master Bed
- There are drip marks seen on the wooden beams above the master bed and in the master closet. The areas were dry at the time of inspection. Further investigation is recommended.

Master bedroom, drip marks

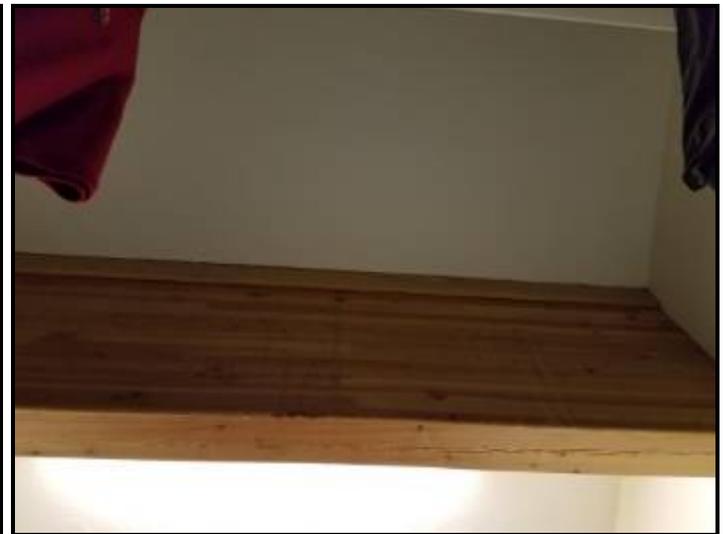
Master closet, drip marks

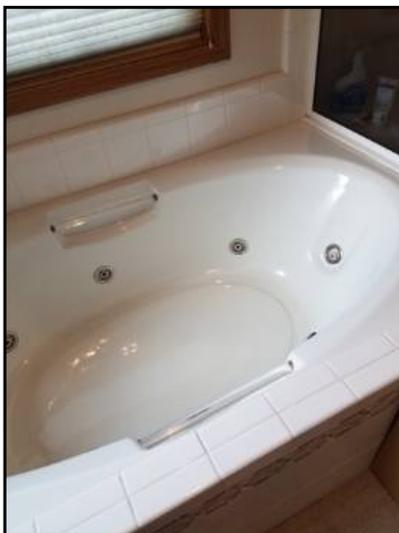
- Overall condition of bathroom tub/shower fixtures is satisfactory.
- **Leaks seen at the shower head connections when on, further assessment advised. Master Bath**
- **The jet tub motor did not come on when the control switch was operated. Further investigation is advised. We do not fill tubs or inspect the performance of the jets as part of this inspection. Master Bath**

Master, jet tub

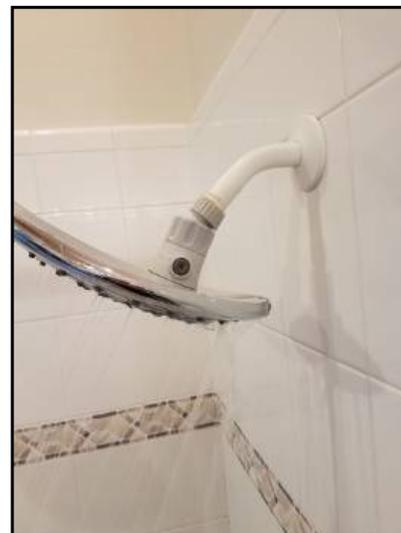
Master, shower head

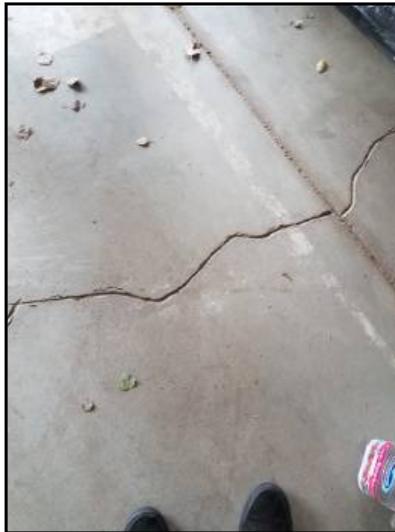
- Typical or thin cracks noted. It appears some cracks have been sealed

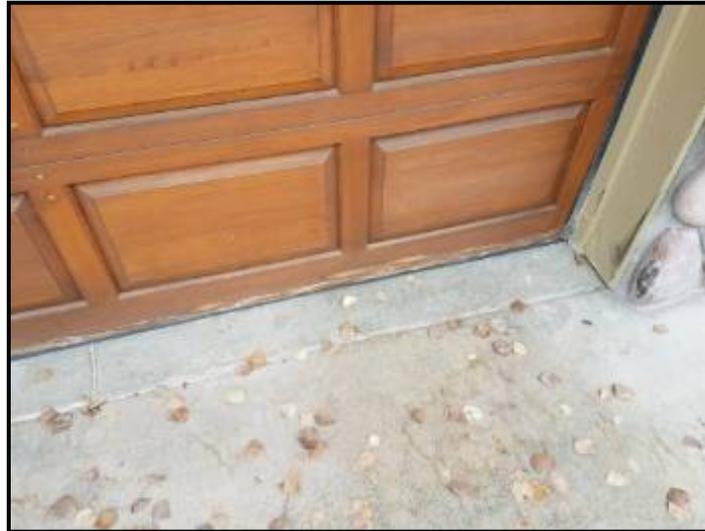
- water / salt damage is noted along the bottom edges of the doors. Does not appear to affect function

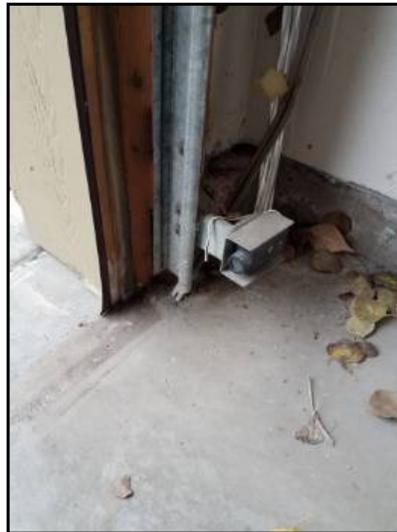
- Automatic door opener(s)- operational
- Eye beam is installed but not functioning properly on the smaller garage door. Further assessment advised by a licensed contractor. Safety concern.

Garage		
Page 37 Item: 5	Opener	<ul style="list-style-type: none"> • Eye beam is installed but not functioning properly on the smaller garage door. Further assessment advised by a licensed contractor. Safety concern.
